**AIRCRAFT ACCIDENT REPORT**

**MD-11F, Registration [REDACTED]**  
**King Khalid International Airport – Riyadh**  
**Kingdom of Saudi Arabia**

**Abnormal Runway Contact (ARC)**

**15 Sha'aban 1431 H – 27 July 2010 G**

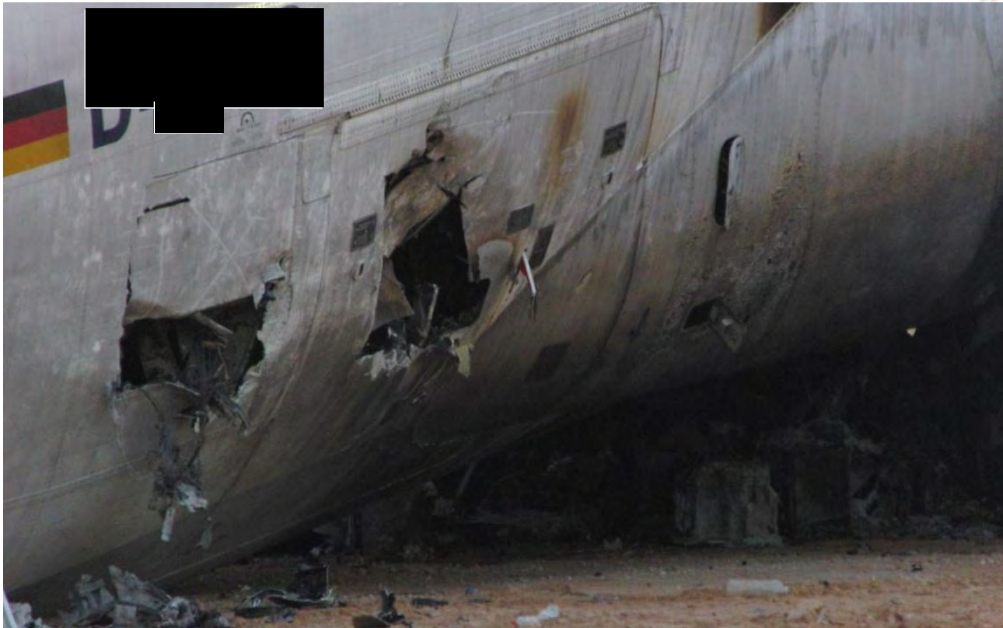
Figure 2: Access to the Flight Recorders

The Cockpit Voice Recorder (CVR) and the Digital Flight Data Recorder (DFDR) were located just aft of the lower center cargo door at Fuselage Station (FS 1801). Since this cargo door could not be opened to access the recorders and a lot of debris from the fire fell in this area, the firefighters used high powered metal cutting saws to cut through both the lower center cargo door and the fuselage aft of this cargo door (Figure 2). Both flight recorders were recovered.

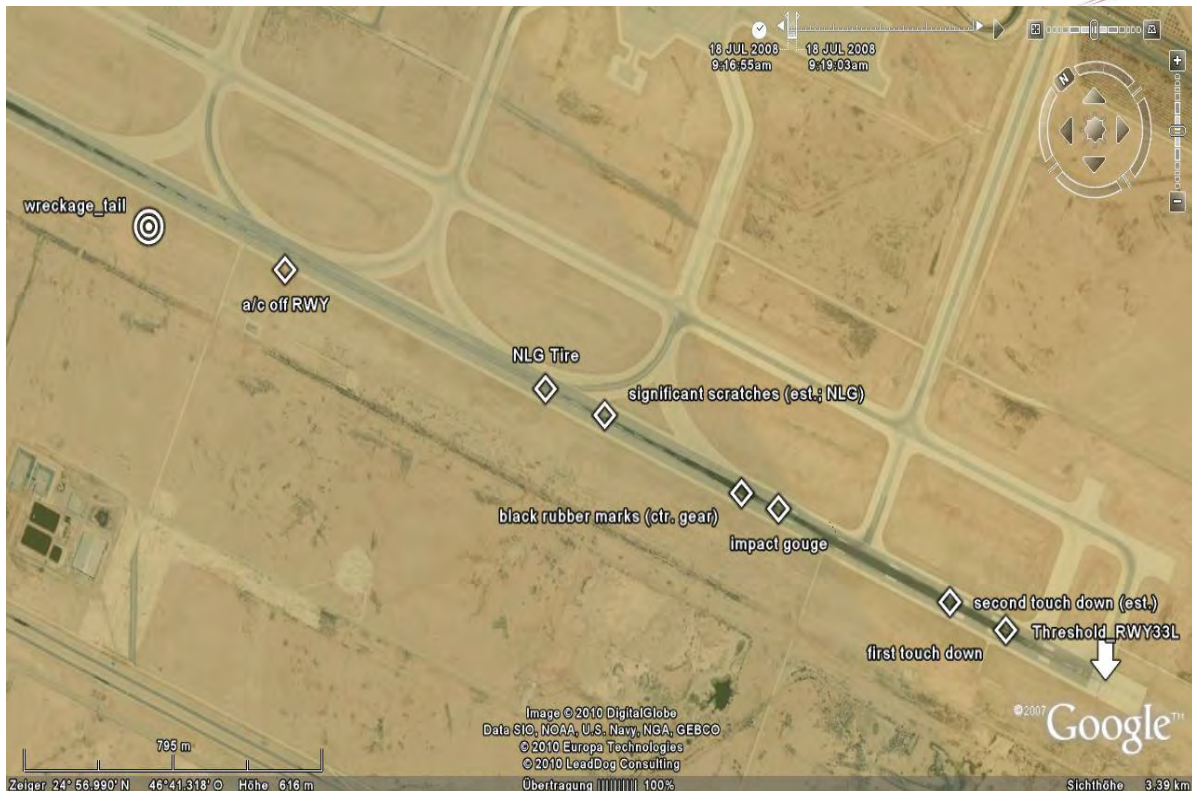
Figure 8: Marks and Debris

The aircraft landed on Runway 33L at the 945 foot runway mark (green circle). The aircraft bounced following the first touchdown, touched down a second time and bounced a second time. A third and final touchdown at the 3200 foot runway mark (red circle) resulted in the aft section of the fuselage to rupture just aft of the wing. The aircraft continued down the runway with the tail dragging until it departed the left side of the runway at the 7400 foot runway mark, where the nose gear collapsed. After departing the runway, the aircraft traveled through a gravel area before it came to rest at the 8800 foot runway mark on a heading of 310°, 300 ft left of runway 33L centerline, across from taxiway exit A5 (Figures 7 and 8 and, Figure 3 of Appendix C). A fire started after the rupture of the aft fuselage.

The runway and the wreckage trail were observed many times and, the marks and debris were documented and plotted. Significant items along the runway and wreckage path are as follows:

- Six parallel stripes of rubber residue were found 945 ft from the runway threshold indicating that the aircraft touched down with the two main landing gears and the centre landing gear. (Figure 7 - green circle and Figure 9 – green arrows);

- Tail impact at 3200 ft from the threshold. This impact consist of a deep gouge and additional scratches (Figures 7 and 10 – red circle). Beyond this point the number of parts and pieces increased;

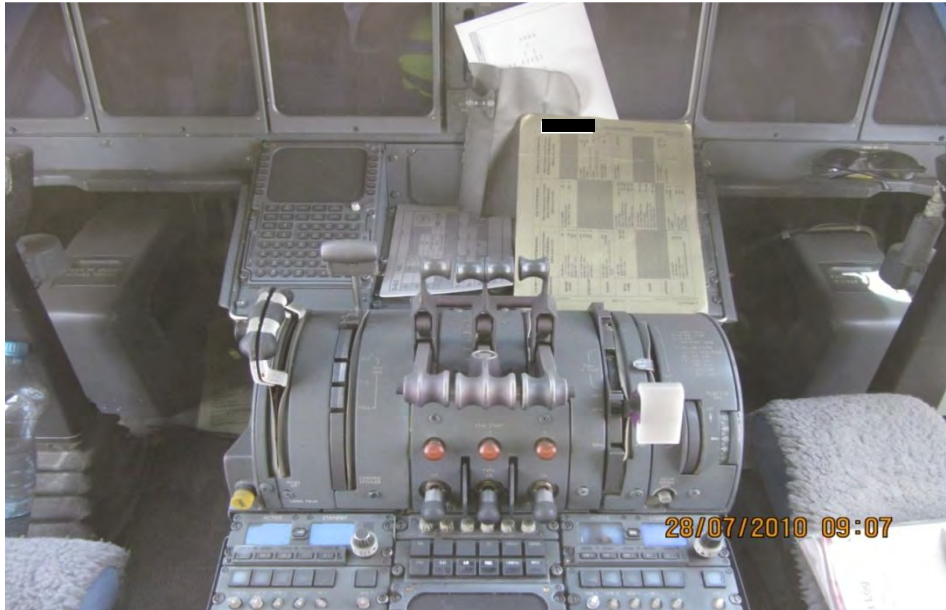
Figure 19: Centre Pedestal

The list of the circuit breakers which were found opened is at Appendix A.

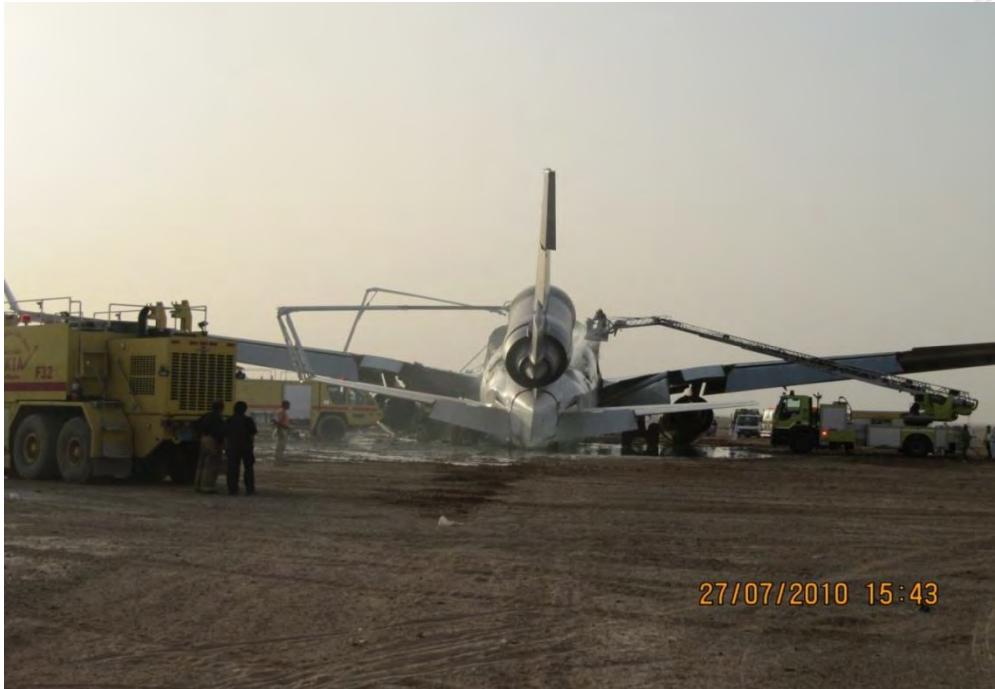
Figure 26: Fire Fighting Operations

The fire fighting operation continued until 04h30 the next day, 28 July 2010 (Figure 26). The accident site was released to the Investigator-In-Charge (IIC) at 10h30 on 28 July 2010.

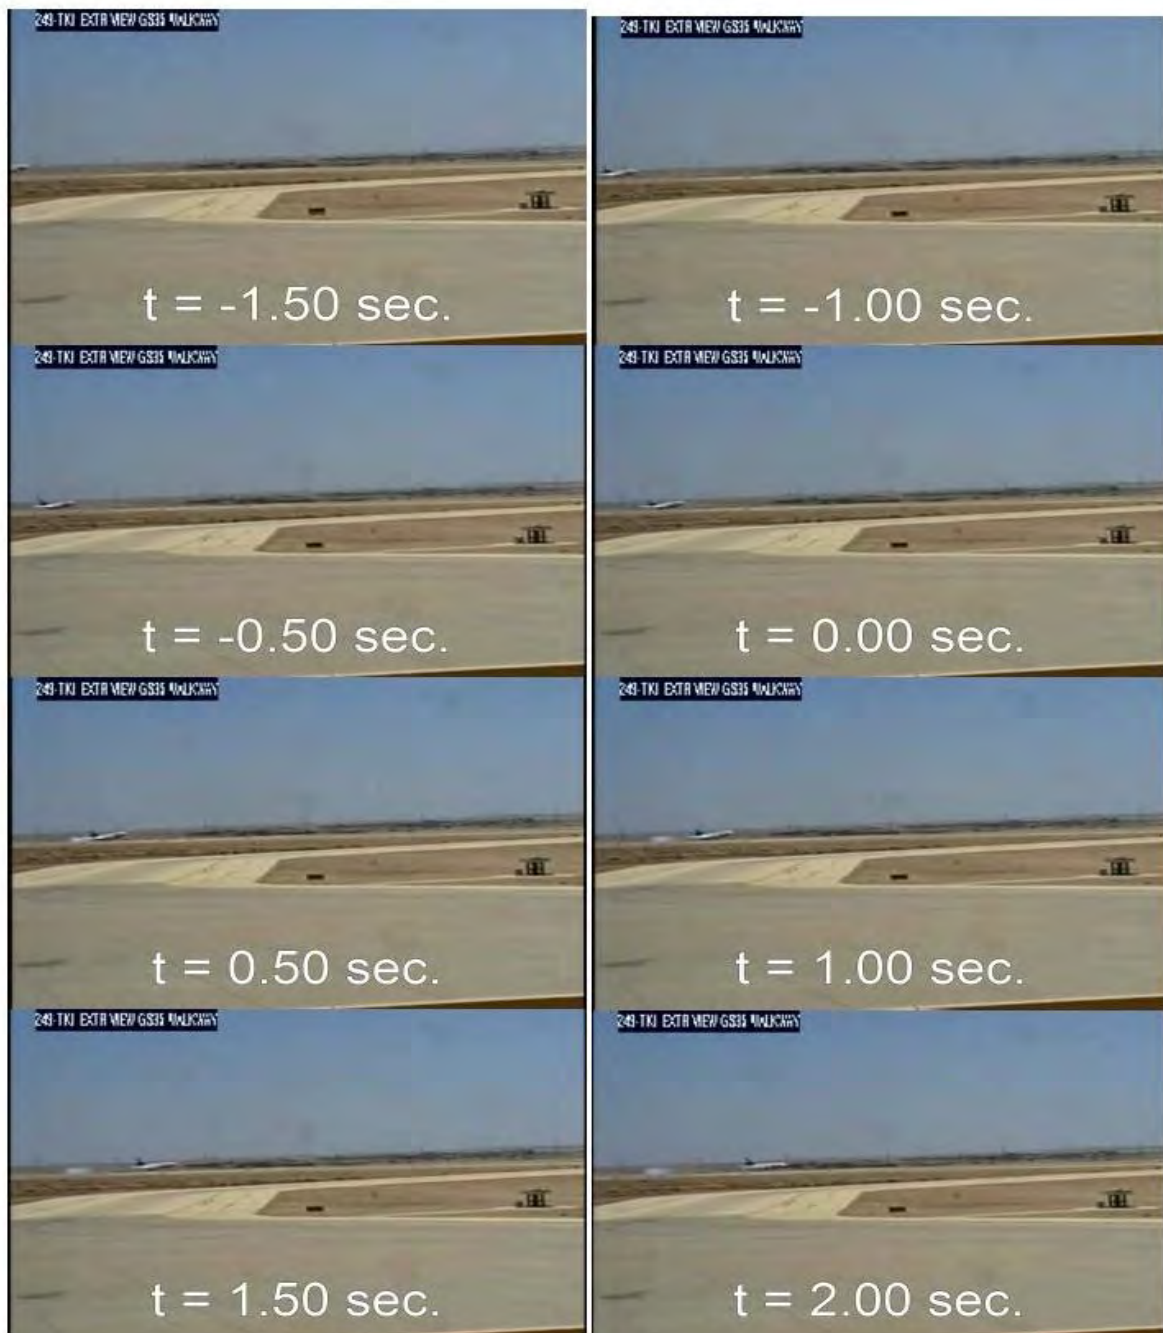
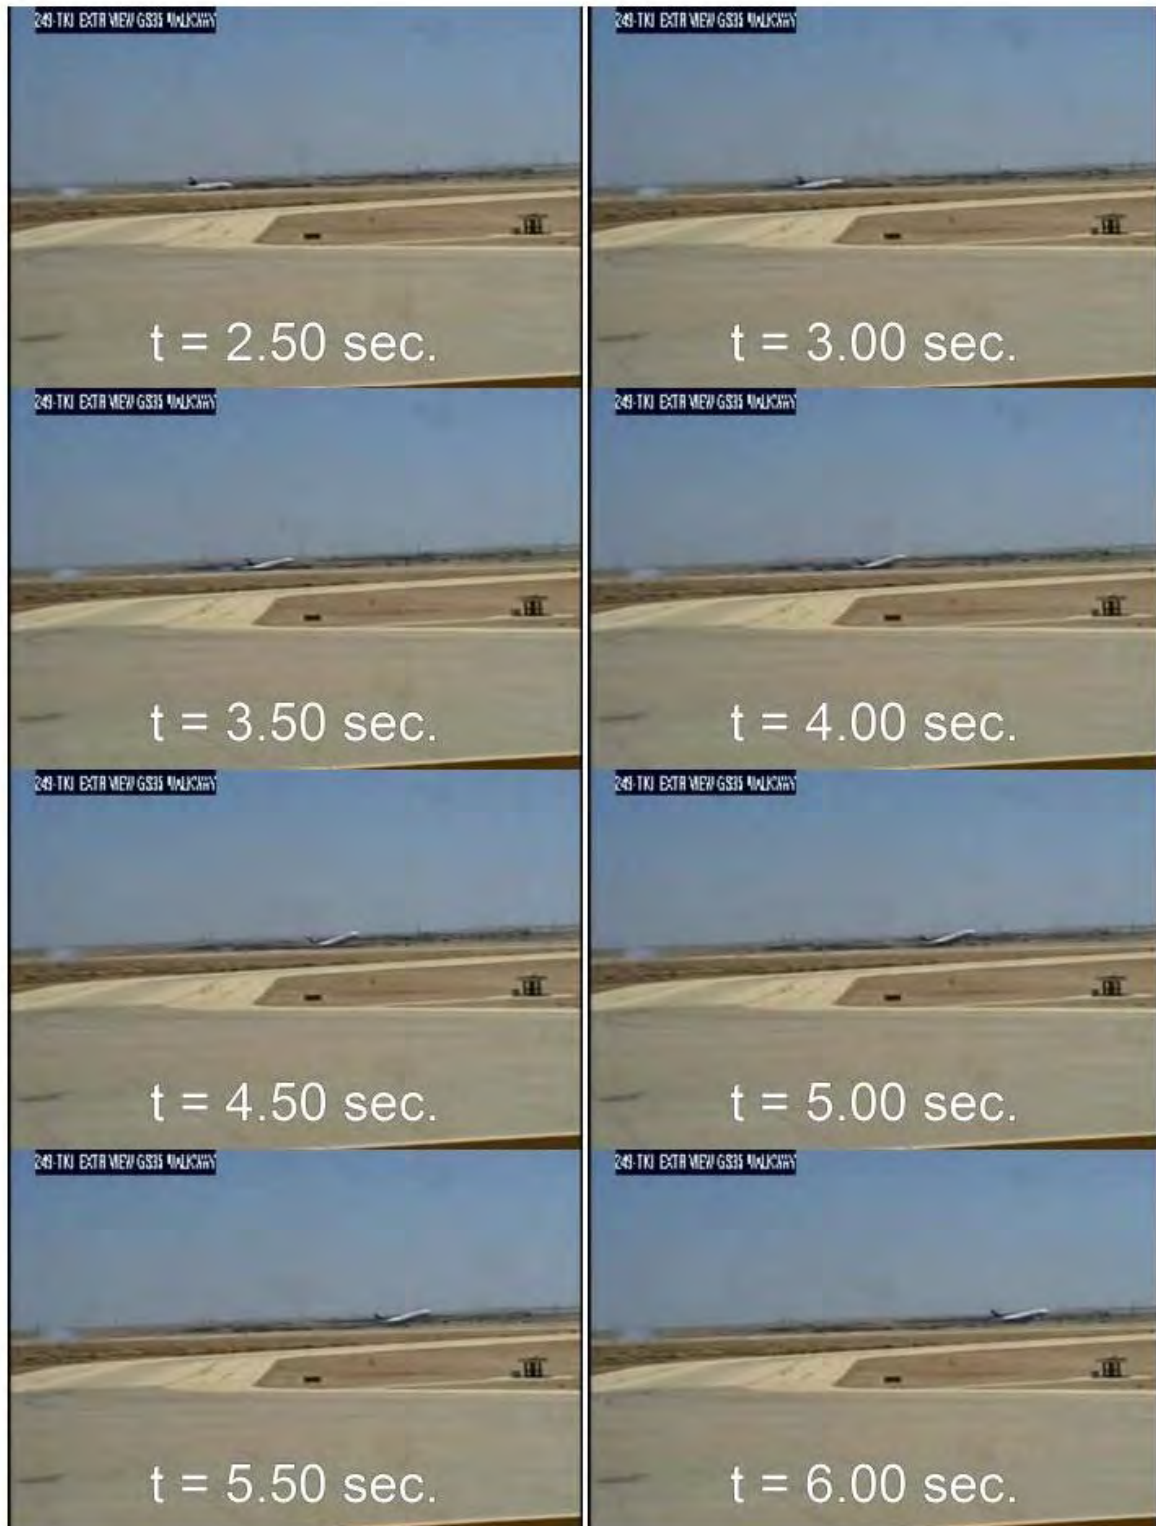
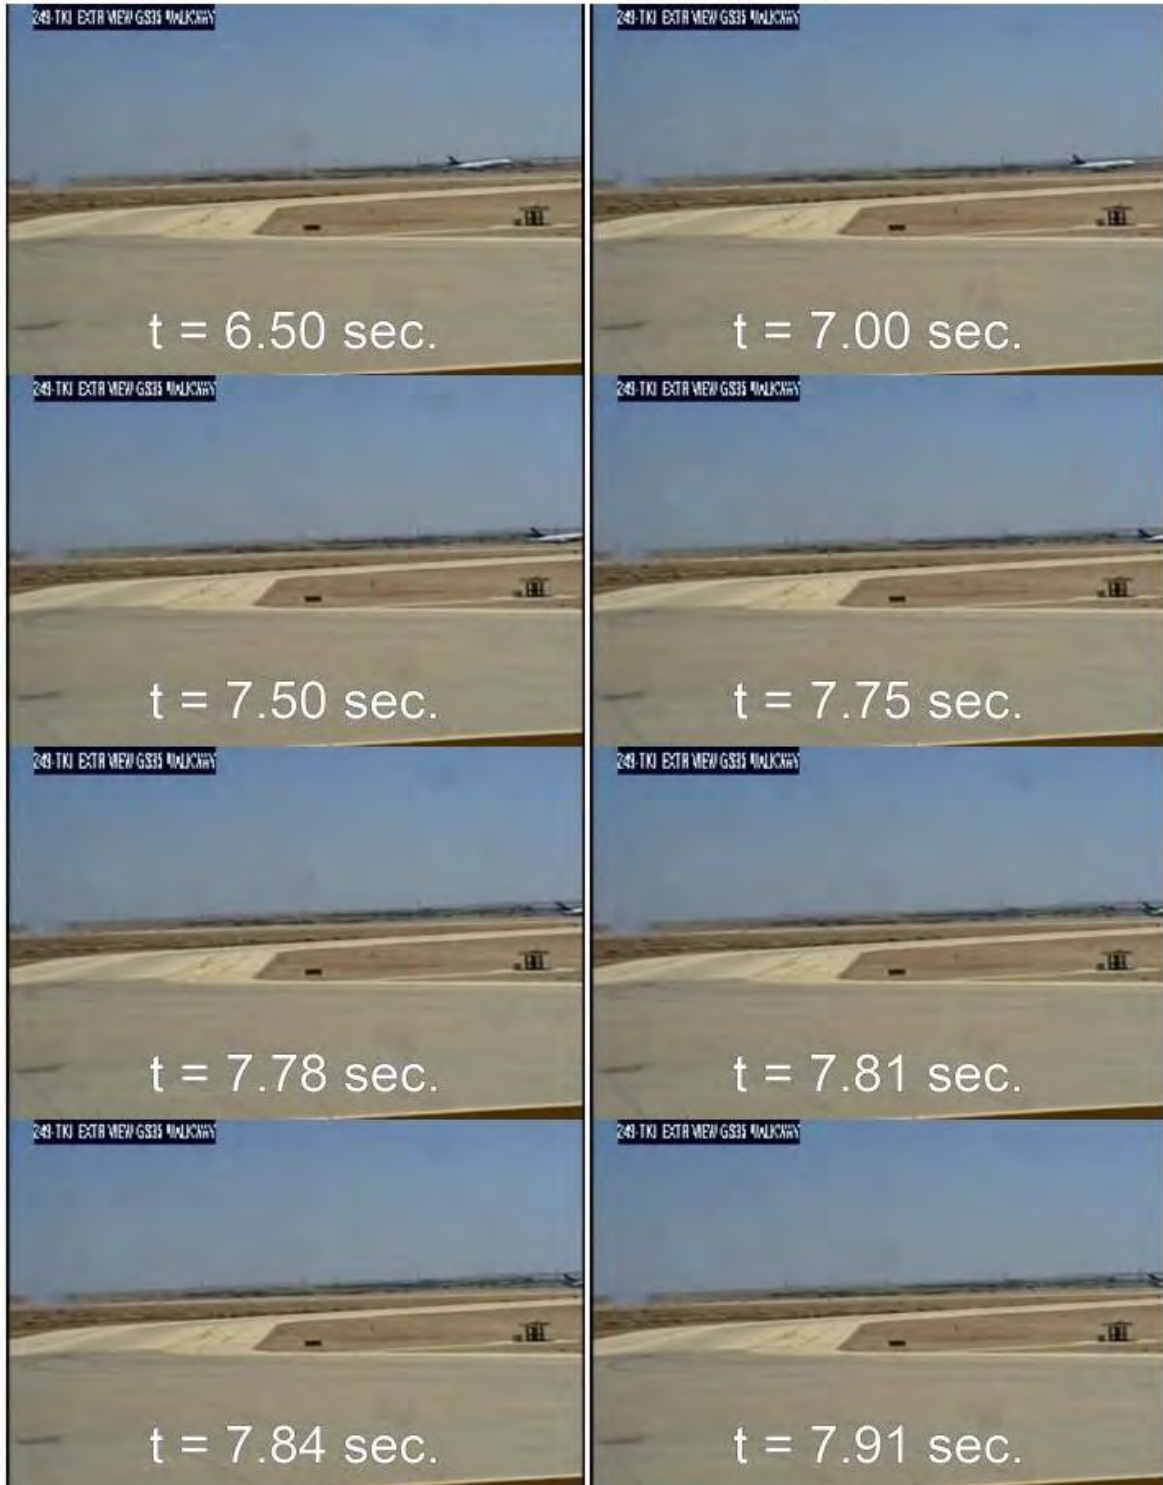
Figure 1 (page 1 of 3). Still frames from first security camera.

The video recording of the landing captured by the airport security camera (Appendix C- Figure 1) showed that after the first touchdown of the main gear, the aircraft bounced back into the air and then touched down a second time with both the main gear and nose gear in a nearly flat pitch attitude. The aircraft bounced again with the nose rising rapidly. This second bounce was much higher than the first. The aircraft again pitched over and returned to the runway. Following this third touchdown, the aircraft exited the field of view of the security camera.

Figure 1 in Appendix C contains a series of still frames from the video recording of the airport security camera from a point on final approach at  $t = -1.5$  seconds (sec.) before the first touchdown to the exit of the aircraft from the camera field of view following the last touchdown at about  $t = 7.9$  sec. after the first touchdown. The first touchdown occurs at  $t = 0.0$  sec.

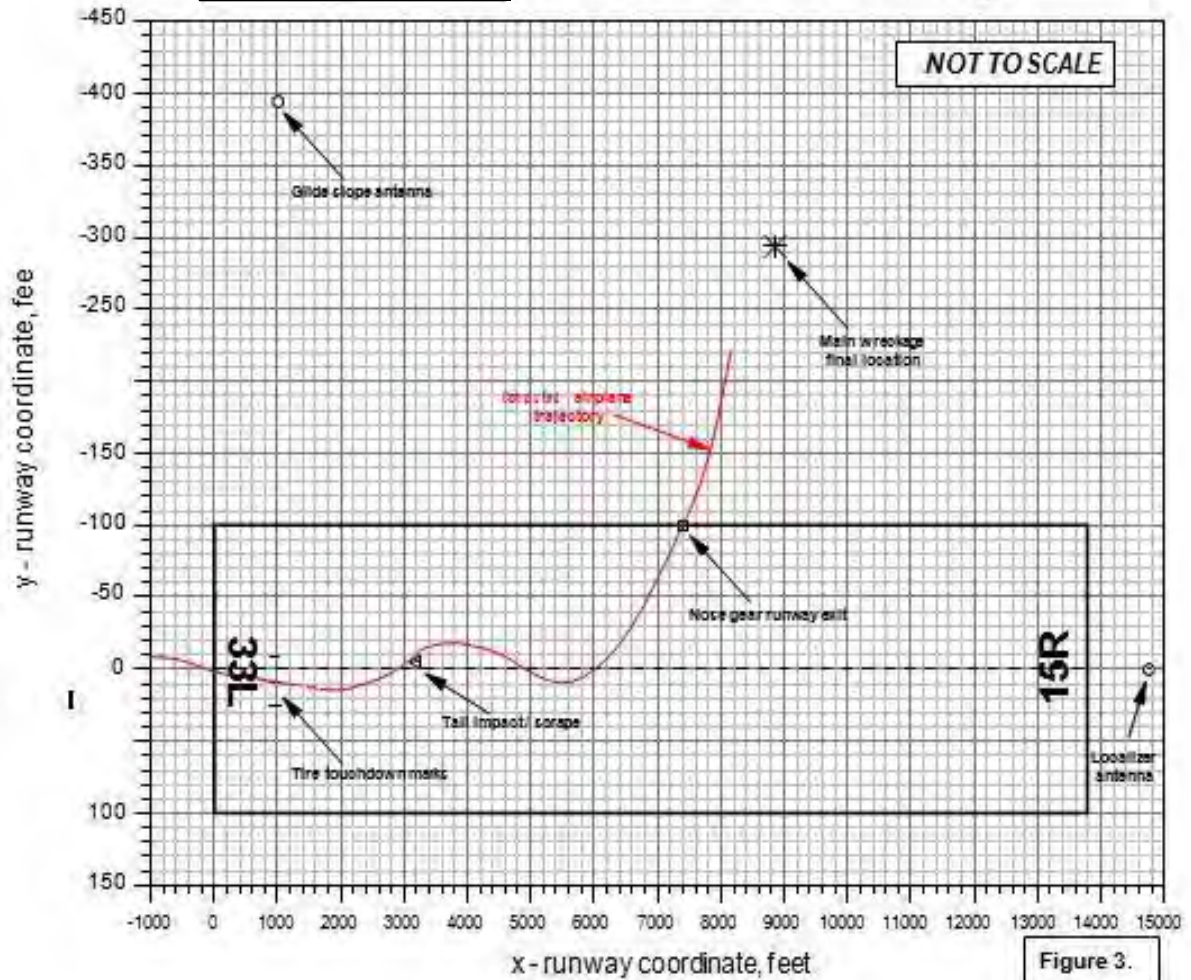
## Ground scars and markings

Several ground scars and markings provided evidence of the aircraft trajectory following the first touchdown. ( Figures 7 to 12 and Appendix C - Figure 3)

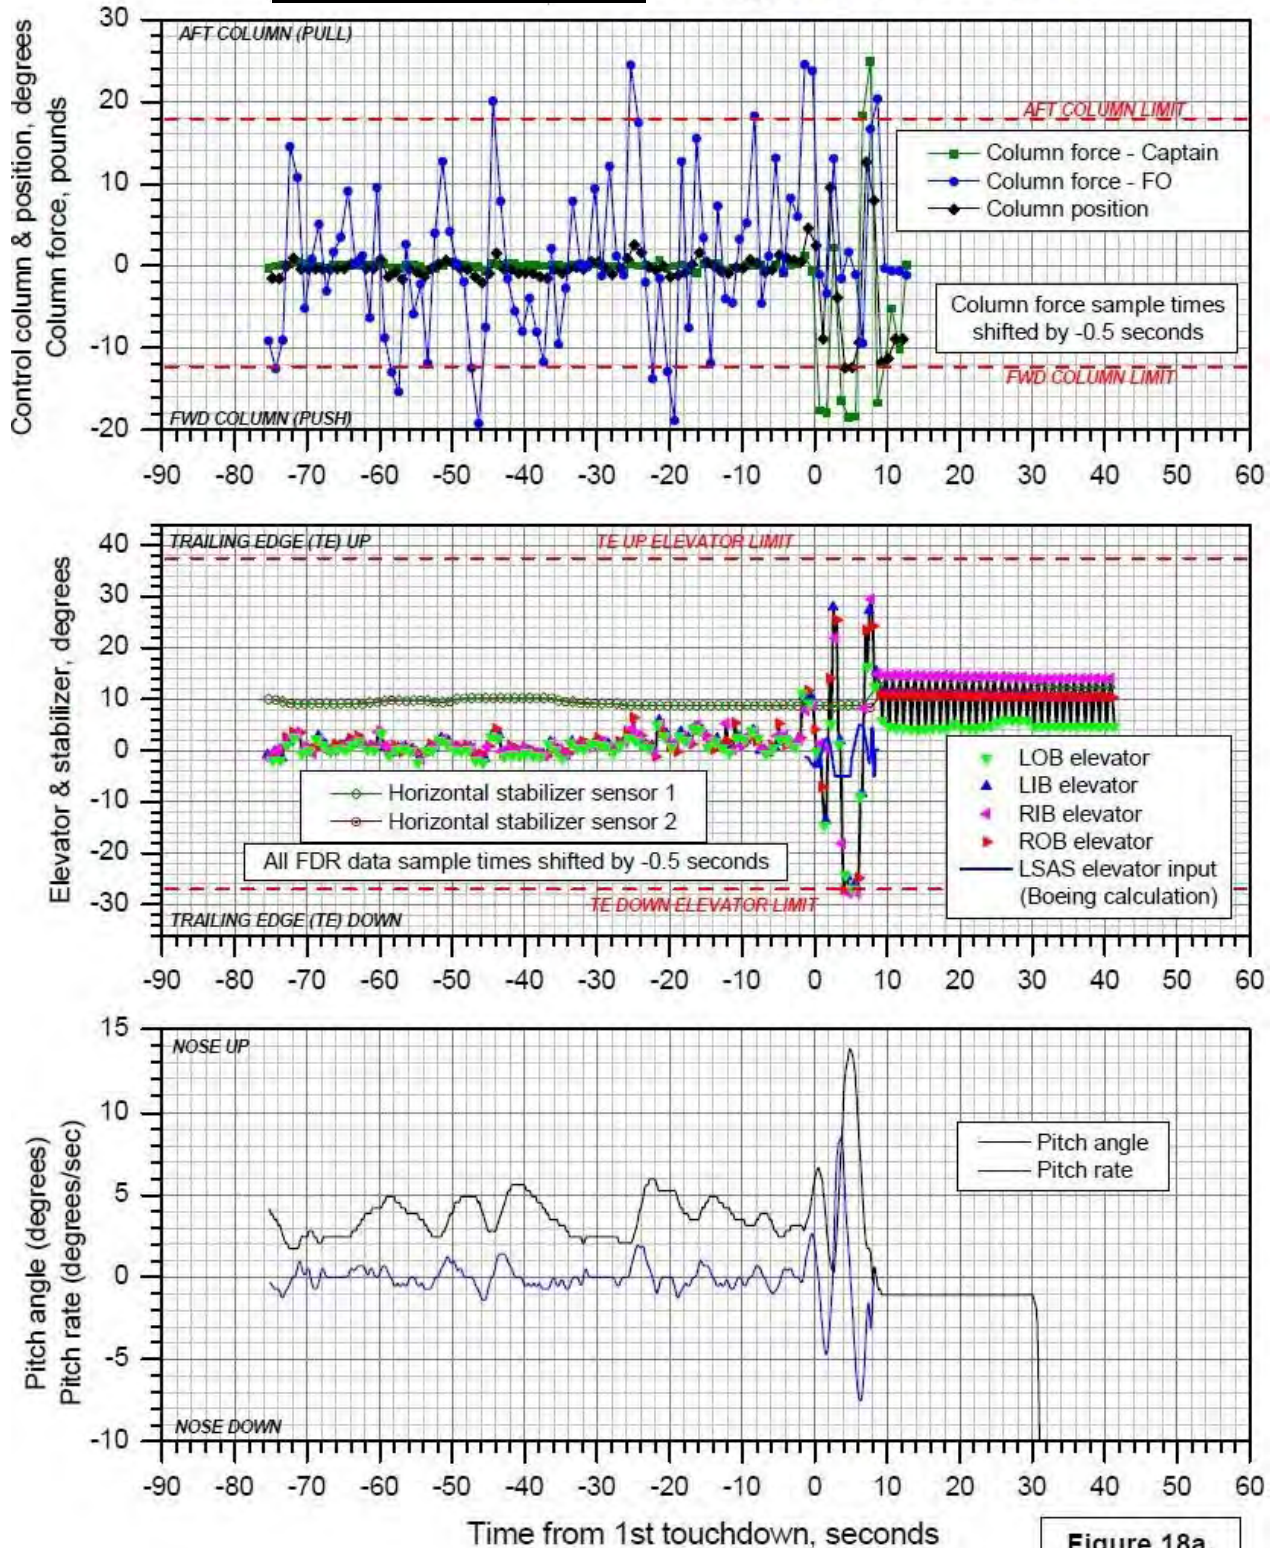
Figure 18a.

This study covered many aspects of the flight. The pitch control and responses during the bounces were of particular interest. Figures 18a and 18b in Appendix C present the longitudinal flight control parameters. Control column position and, left and right column forces are shown in the top plots in the

The first touchdown (main gear) at a *nlf* of 2.1g and a sink rate of -13 ft/sec resulted from a late flare initiated by the FO between 1.7 and 2.0 sec/23 to 31 ft above the runway before touchdown. This is indicated by the start of the upward movement of the elevators and the increase in pitch angle (Appendix C – Figure 18b). While the first touchdown resulted in a bounce, the landing was recoverable. The severity of the subsequent touchdowns was not a consequence of the first touchdown, but primarily a result of the pitch angle during the bounces, which resulted from the actions of both flight crews on the control column.
